SmartMelter® Blind Trial at a Tableware Furnace

INTRODUCTION

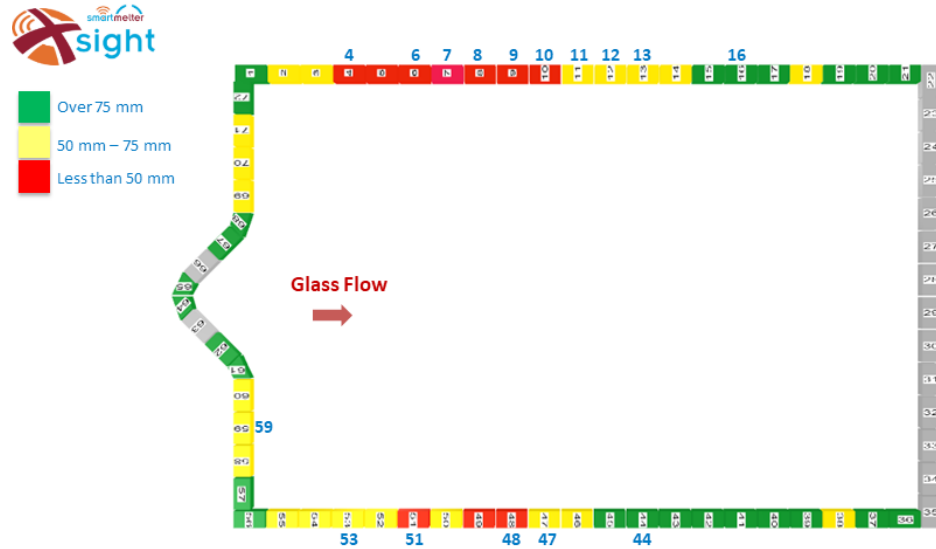
Figure 1
Furnace Layout and Measurement Spots.

Measurements of the fused cast AZS were taken on the left and right sidewalls, doghouse and charging end wall at the metal line for thickness (see Figure 1).

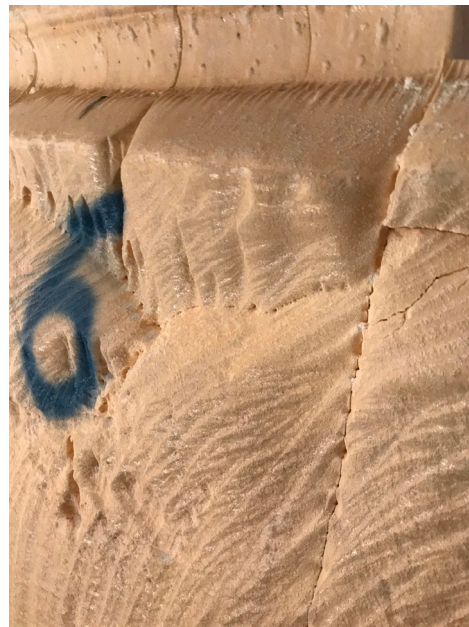
Figure 2
Typical Sidewall Erosion Pattern at the Metal Line..

There was no glass penetration into the sidewall insulation, indicated by visual inspection from inside the drained furnace and by removal of the insulation during demolition. The SmartMelter® results reported no glass penetration on the furnace. Observations from inside the furnace showed erosion at joints, but all AZS sidewalls were intact and had no breach.

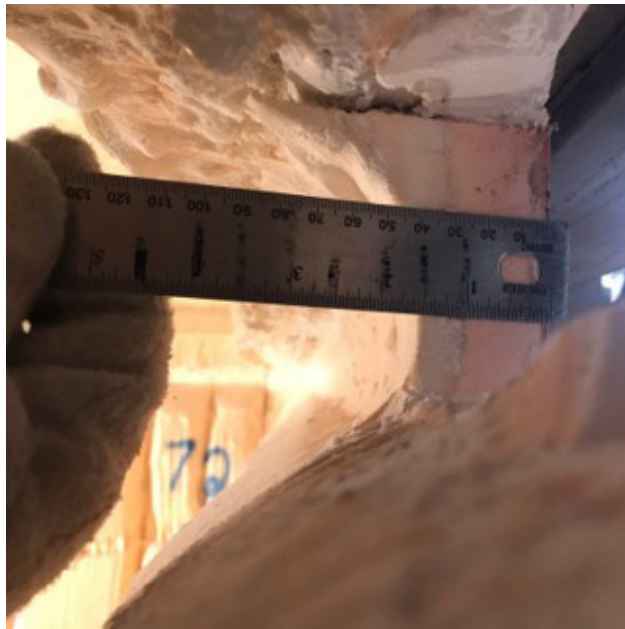
Figure 3
AZS Thickness at Metal Line. Left
Sidewall at Block 7.

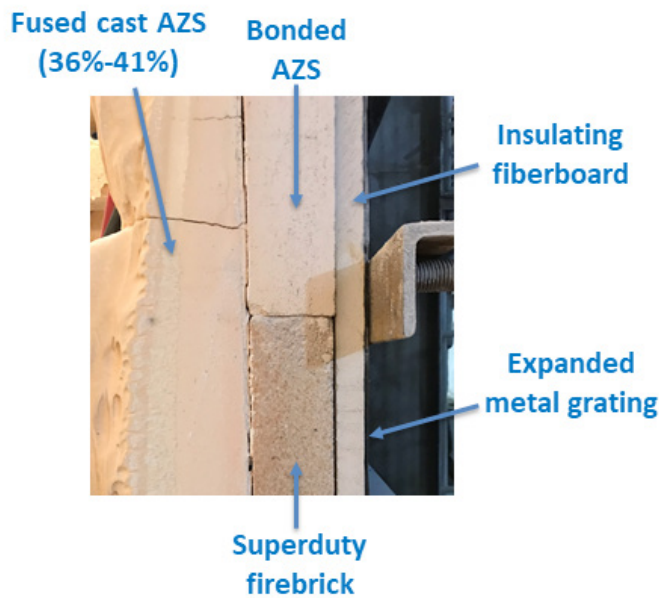
Figure 6
Sidewall Insulation: 76 mm superduty firebrick or 76 mm Bonded AZS with 25 mm Insulating Fiberboard with Expanded Metal.
