Safer cullet use: Detecting metal infiltration in furnace bottoms

Dr Yakup Bayram discusses the successful application of advanced radar technology to detect and map metal infiltration in furnace bottoms.

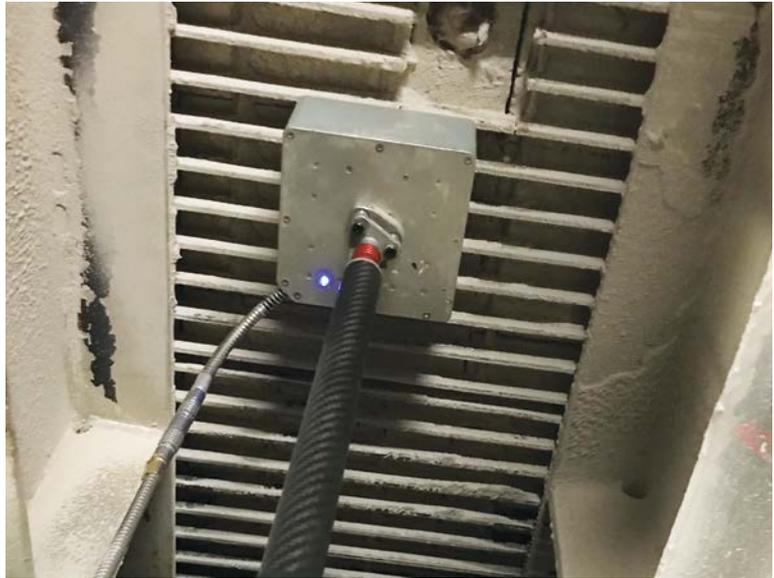
SmartMelter sensor to map metal infiltration in a furnace bottom.

After reviewing the results of SmartMelter's validation trial on a furnace bottom, the manufacturer asked the SmartMelter team to demonstrate its ability to detect not just glass but also metal infiltration in a multi-layer furnace bottom. The team was happy to explore this expanded use of its technology. SmartMelter was used on multiple furnaces at the manufacturer's facility to produce 3D mapping of infiltration, including the metal pieces.
