# SmartMelter<sup>®</sup> Blind Trial At a Float Line

## INTRODUCTION

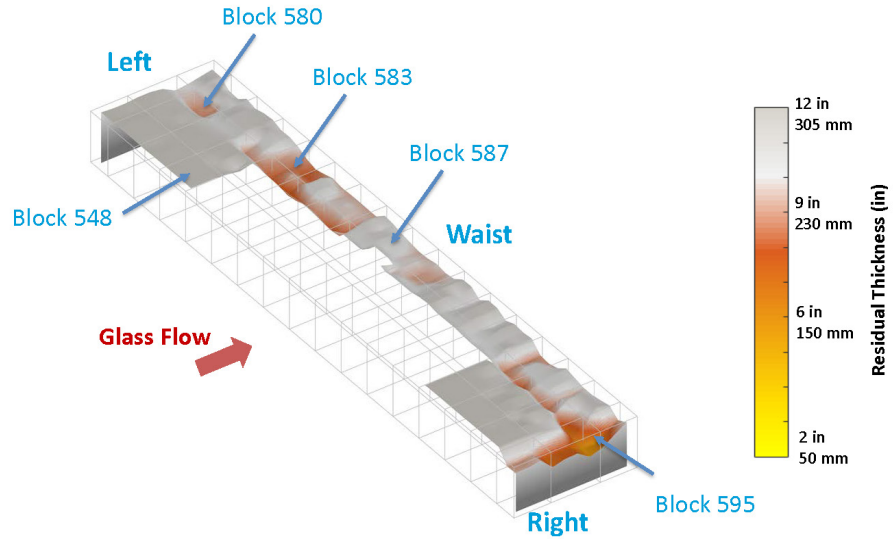
**Figure 1**  
Furnace Layout and Measurement Spots.

Measurements were taken on a total of 6 blocks (see Figure 1).

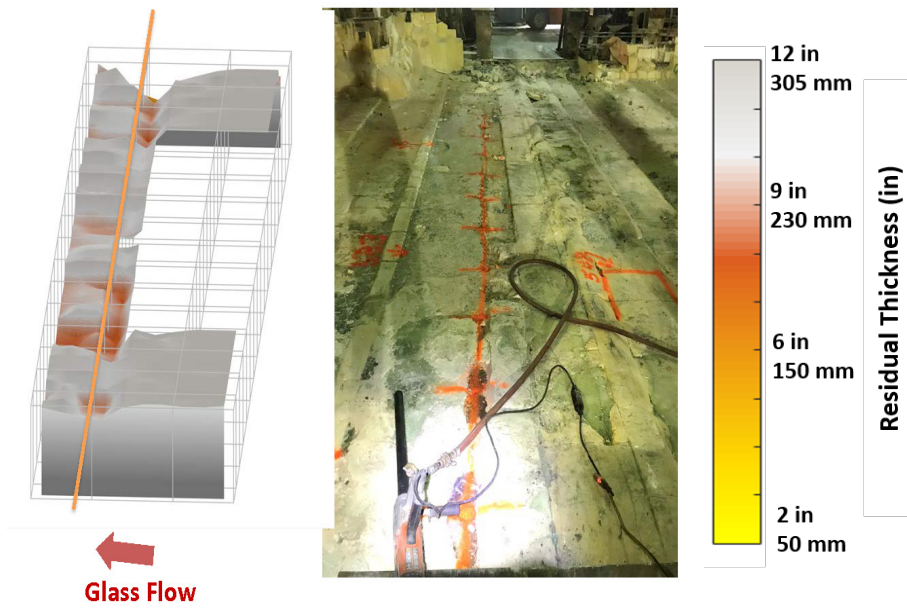
**Figure 2**  
The orange line is the same location as the orange paint. Cold glass did not drain out of the eroded areas.

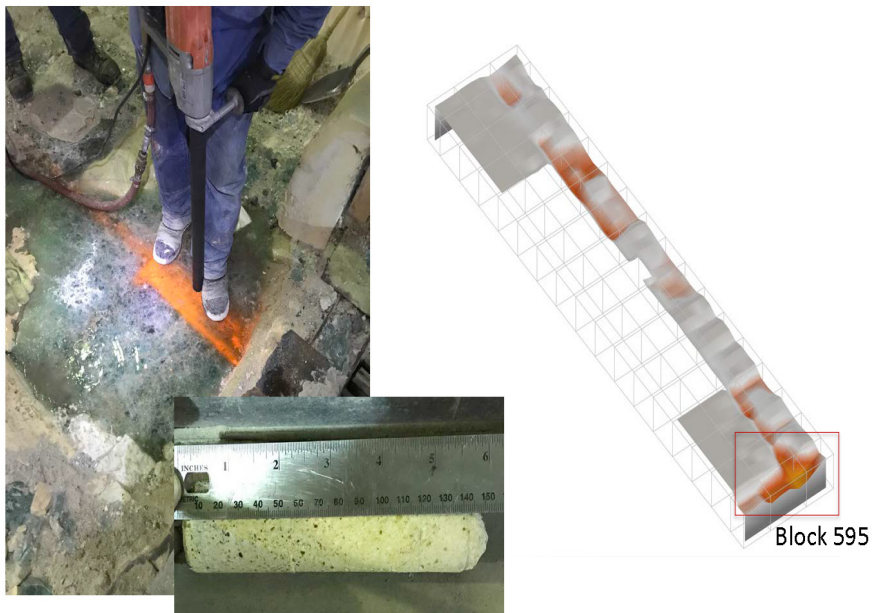
**Figure 3**  
Drilling Block 595. Note the significant amount of glass filling the eroded hole.

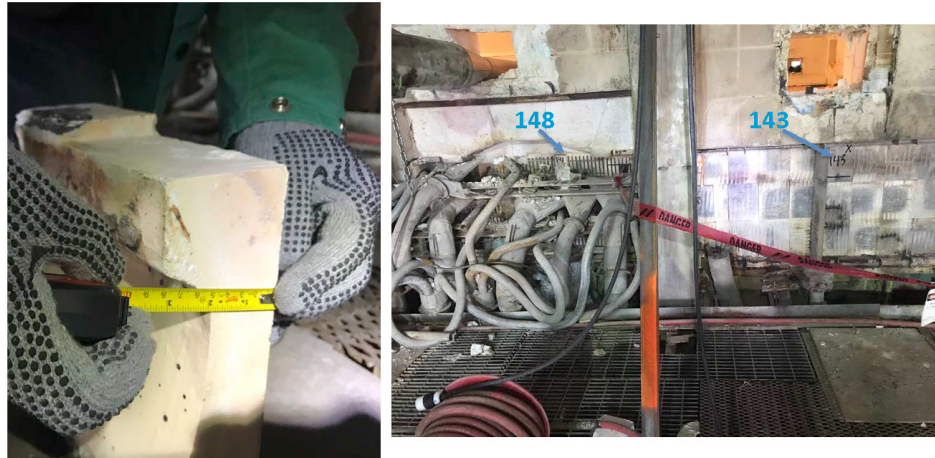
**Figure 5**

Measurements were taken on a total of 2 blocks (see Figure 5).

The Image on the Left is Block 143. The Image on the Right Shows the Placement of Blocks 148 and 143..

Sidewall Block Number	SmartMelter Thickness	Physical Thickness	Difference
143	47 mm	47 mm	0 mm
148	30 mm	29 mm	1 mm
