Refractory Thickness Sensor (RTS)
耐材厚度探测传感器 (RTS)

Blind Trial at a Container Glass Furnace
在瓶罐玻璃炉上的盲试

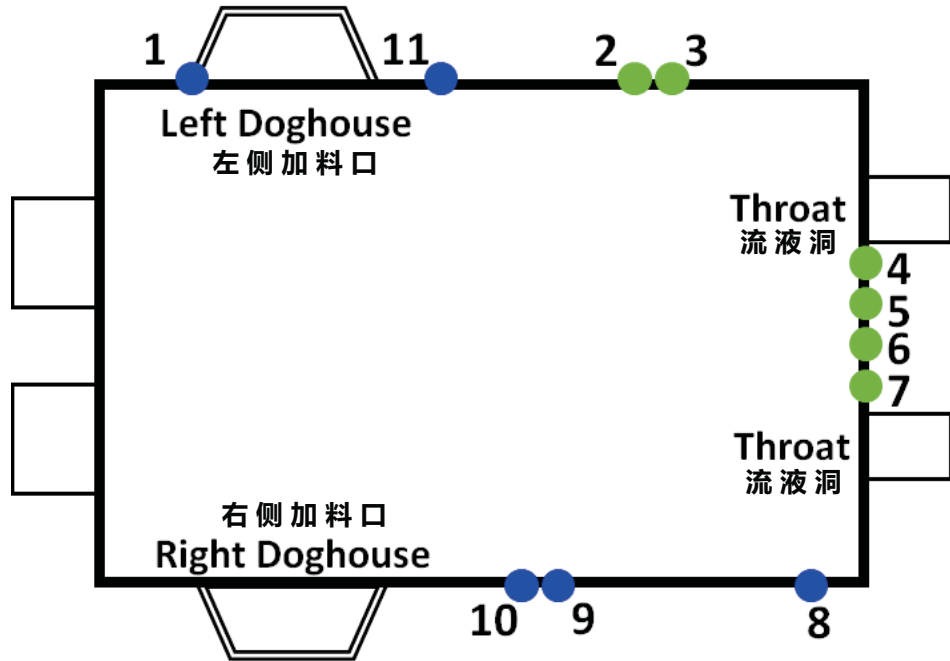
Figure 2
Furnace Layout and Measurement Spots

The Vidrala furnace was an end port-fired furnace. Measurements were taken at two spots near the left doghouse, two spots on the left sidewall, and three spots on the right sidewall. There were also four spots measured in between the two throats. Altogether, eleven areas of the furnace were measured by the RTS sensor

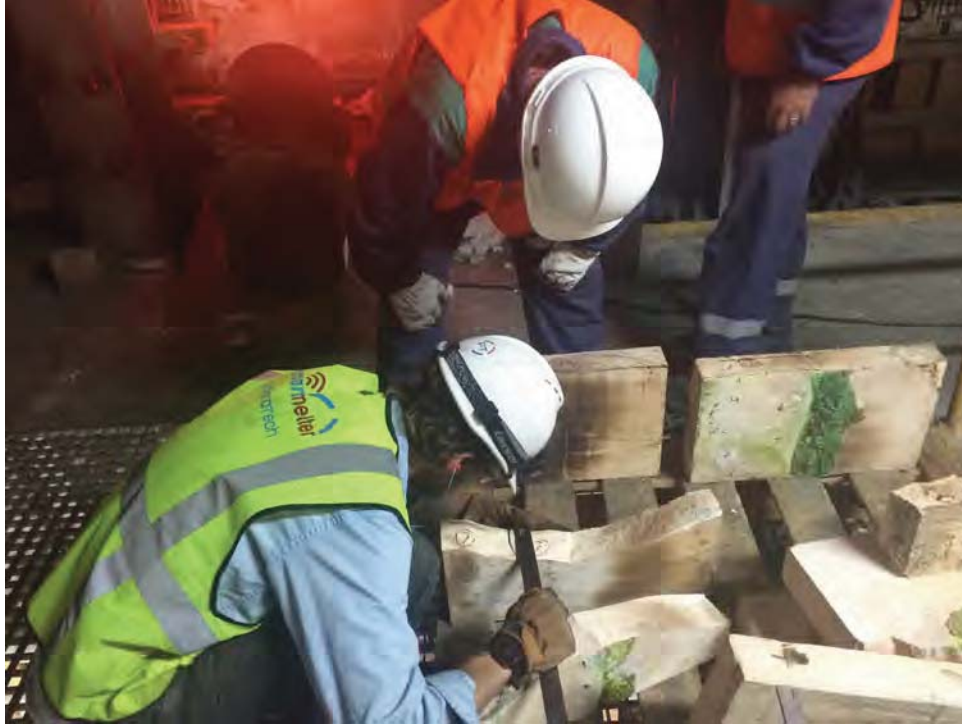
Figure 7
Vidrala and PaneraTech team measuring actual wall thickness after the recovery of the blocks.
.....

These actual block thickness were measured with Vidrala team as seen in Figure 7.
