SmartMelter® Blind Trial at a Tableware Furnace

INTRODUCTION

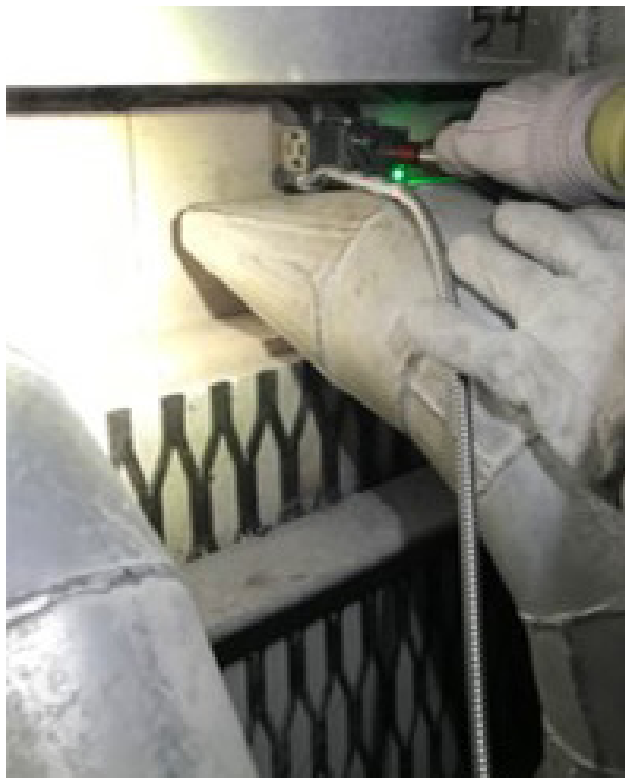
Figure 4
SmartMelter® Team Member Taking
Measurements at The Metal Line.

Physical measurements at the metal line were performed by removing a portion of some of the measured blocks and measuring the thickness of the block. This was done in 17 locations.
